Managing Structures Affected by Delayed Ettringite Formation and Alkali-Silica Reaction

by Dr. David Rothstein, DRP, a Twining Company

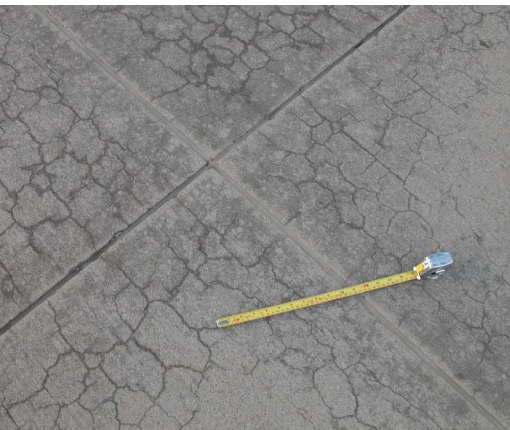
Photograph of map cracking on concrete pavement affected by alkali-silica reaction. All Photos and Figures: Dr. David Rothstein.

The starting point for all investigations is on-site visual inspection of the structure and documentation of deterioration such as cracks, deformations, displacements, joint deterioration, pop-outs, efflorescence, and discoloration of surfaces.¹ Although map or pattern cracking is a classic indicator of internal expansion, the presence of reinforcement and prestressing (pretensioning or post-

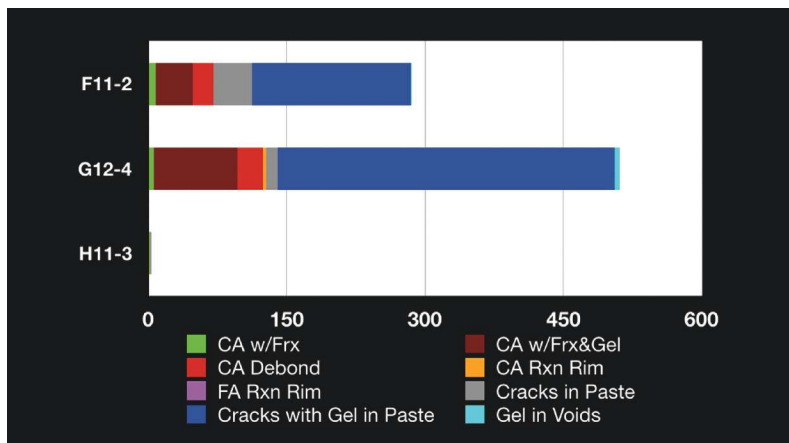
Summary diagram of Damage Rating Index (DRI) results, showing how the method documents variations in the amount of damage. The bar chart summarizes the amount of distress associated with different indicators of distress associated with alkali-silica reaction (ASR). An entire bar represents a total DRI score, with higher numbers indicating more damage. The different colors within a bar indicate the different forms of damage that contribute to the total score. F11-2 and G12-4 show extensive damage, primarily associated with cracks with gel in the paste, and H11-3 shows essentially no damage. Abbreviations are as follows: CA, coarse aggregate; FA, fine aggregate; Frx, fracture; Rxn, reaction.

Petrographers can categorize the severity of ASR qualitatively or quantitatively. In qualitative rankings, severe ASR is indicated by clear evidence of macroscopic cracking; moderate ASR by the presence of associated microcracks; and minor ASR by the presence of gel without cracks or microcracks. Quantitative methods include the Damage Rating Index (DRI), which assigns numerical “scores” to indicate the degree of damage.² There is no standardized threshold score to indicate a particular level of damage, but the DRI can nevertheless be a useful tool to compare different parts of a structure or assess the same parts of a structure at different times.
